**Abstract Code: AP10**

**Debris flow hazard assessment of abandoned tailings ponds in Friuli Venezia Giulia, Italy**

**CNR Research Institute for Geo-Hydrological Protection, Padova**

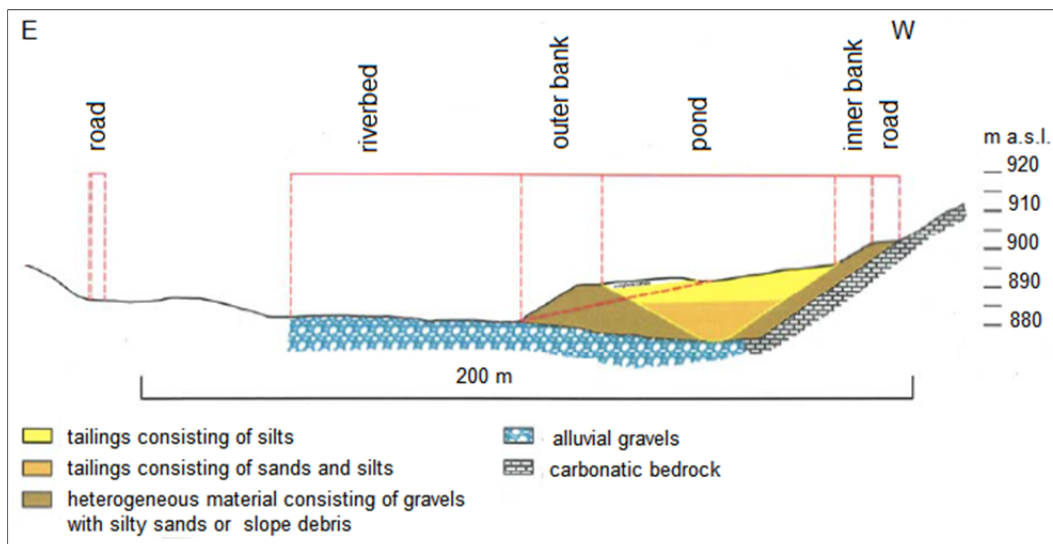
Figure 2. Cross section of the tailings pond 2.

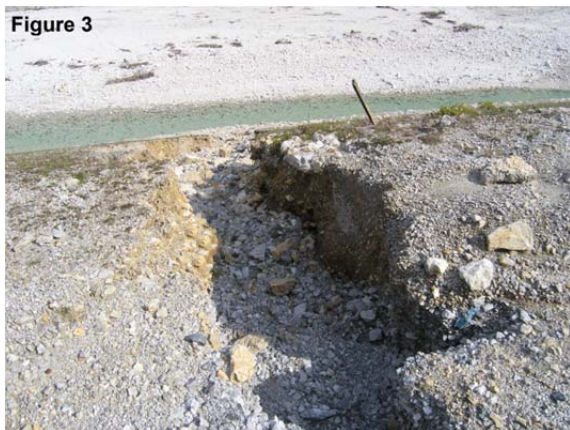
Figure 3

**Geotechnical problems.** The maximum height of the embankments, today, varies from 15 to 22 m. Taking into consideration the construction practices when the tailings ponds were created, several geotechnical issues arise, among which: (a) the ponds were founded without any measures to protect the aquifers; (b) the stability of the embankments is questionable as they are made of loose granular material susceptible to liquefaction; (c) the location of the tailings ponds along the valley permits, in case of heavy rain, the water to accumulate in the abandoned ponds, causing a possible mud overflow to the valley stream by erosion channels cut through the embankments (Figs. 3, 4) or banks erosion caused by the main stream itself.

Figure 3. Erosion channel cut through the embankment of a tailings pond.

materials would extend the contamination over a large inhabited area. After the risk assessment, the issue is to undertake measures to protect the embankments from erosion and possible failure.

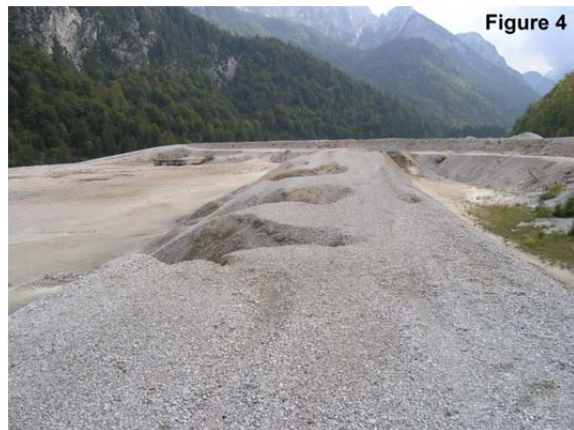
Figure 4

Figure 4. Extensive erosion ditches through the embankment of a tailings pond.

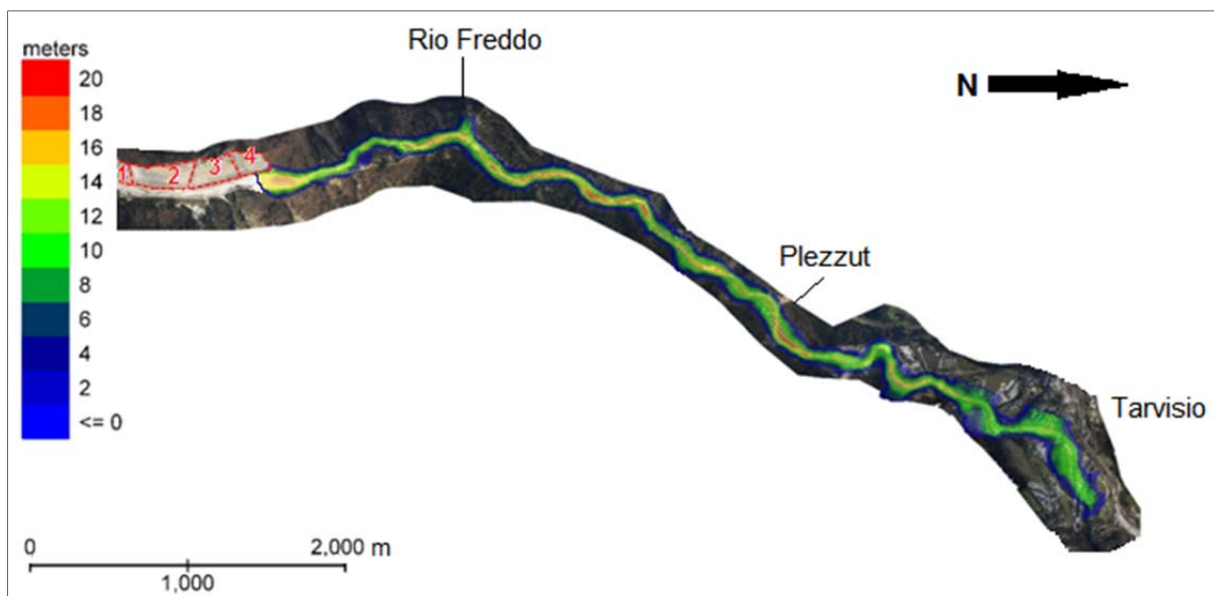
- The hamlet of Rio Freddo can be affected by the debris flow also even in the case of the less severe occurrence, represented by the collapse of the single pond 1: the mass would flow through the settlement with a thickness of about 4 m and an average speed of 2.3 m/s, reaching the village after about 11 minutes from the collapse failure. In the case of the heaviest scenario, represented by the collapse of all the four tailings ponds, the flow would reach Rio Freddo after approximately 8 minutes from the flow onset, with an average speed of 3.4 m/s and the remarkable thickness of 14 m (Figure 5).

Figure 5. Maximum flow depth map on the occurrence of a simultaneous collapse of ponds 1, 2, 3 and 4.
