## **Analysis and Management of Changing Risks for Natural Hazards**

18-19 November 2014 | Padua, Italy

Geomorphological analysis of the historic landslide of Sottrù (Badia Valley, Italy) reactivated on December 13, 2012

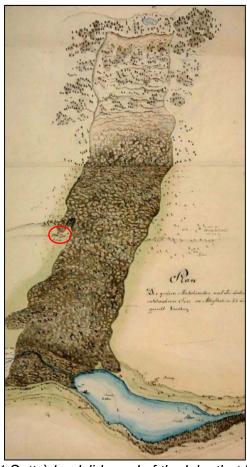
Figure 2. Shape of the 1821 Sottrù landslide and of the lake that formed after the damming of the Gadera torrent. Tiroler Landesarchiv Innsbruck. The red circle identifies the village of Sottrù.

The landslide started on 11 June with small superficial slides, opening of fissures in the ground and soil displacements. Only on 19 June the landslide morphology was similar to the one depicted in historic documents<sup>2</sup> (Figure 2).

The movement seems to have originated from the slope sector above the village of Sottrù, within cultivated and grazing meadows; it propagated downslope passing close to the village and damming the Gadera torrent. Among the effects, the destruction of the hamlet "La Muda" (possibly a station for goods trade along the Gadera torrent) and damages to 17 private

houses are cited. Moreover, the damming of the river created a lake, afterwards called "Lèc de Sompunt" in Ladinian language, with an estimated maximum depth of 35 m, width of 160 m and length of more than 1 km. According to one bibliographic source (Röhrs, 2012), in order to prevent the sudden collapse of the natural earth dam, starting from 1822 the lake was slowly drained and in 1833 it was completely dried up. According to another source (Tetamo, 1998), after rapid snow melting in June 1827 (to be noted once again the occurrence of snow melting at the onset of summer), the natural dam collapsed and the water and debris wave hit meadows and villages valley-ward.

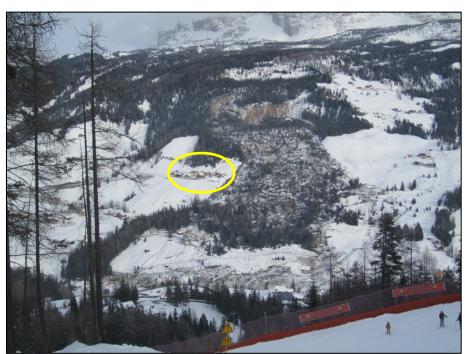
Figure 3. Front view of the 2012 landslide event taken some days after its occurrence. The village of Sottrù is identified by the yellow ellipse. Photograph by M. Soldati.

The geomorphological survey of the Sottrù landslide occurred on 13 December 2012 (Figure 3), performed during the summer of 2014, was aided by the use of a GPS track logger, allowing the precise mapping of geomorphological, hydrographic and hydrogeological details. Important reference maps of the area were the "Carta Geomorfologica dell'Alta Val Badia" and its reference notes (Panizza et al., 2011), and the "Carta Geologica delle Dolomiti Occidentali 1:25.000" (Brandner et al., 2007).

Until a few metres below the village of Sottrù, the lateral scarps are well visible although thinning up. Below Sottrù the accumulation zone starts, reaching the Gadera torrent. From Figure 3 the hummocky morphology characterising the whole toe area can be appreciated.

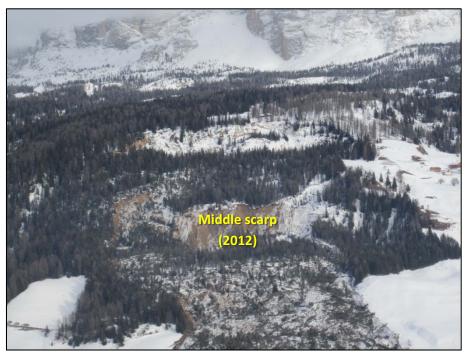
Figure 5. Middle scarp of the 2012 event and related landslide accumulations. Photograph by M. Soldati.

The latter, during the last event, experienced a retreat of some metres uphill and the generation of a fresh new scarp, with more or less the same height of the previous one; the thickness of the collapsed material seems to be relatively thin here, up to 5 m. A translational slide can be hypothesised along the scarp, followed by a rotational slide and partly flow at the slope break (Figure 5). The almost uniform and unbroken snow cover (the last snowy precipitation was on the 8 December, 5 days before the landslide occurrence) reveals a certain degree of compaction of the slid material, probably due to the frozen top-soil layer.

The same evolution seems to have characterised also the left part of the middle scarp, where the sliding uncovered an outcrop of the Wengen Formation layers. Field evidence in the days just after the event, when maximum daily temperatures were still around 0°C, shows water discharges starting from the base of the detrital cover and reaching the base of the scarp, testifying the presence of unfrozen subsurface water.
