**Abstract Code: AP10**

**Debris flow hazard assessment of abandoned tailings ponds in Friuli Venezia Giulia, Italy**

**CNR Research Institute for Geo-Hydrological Protection, Padova**

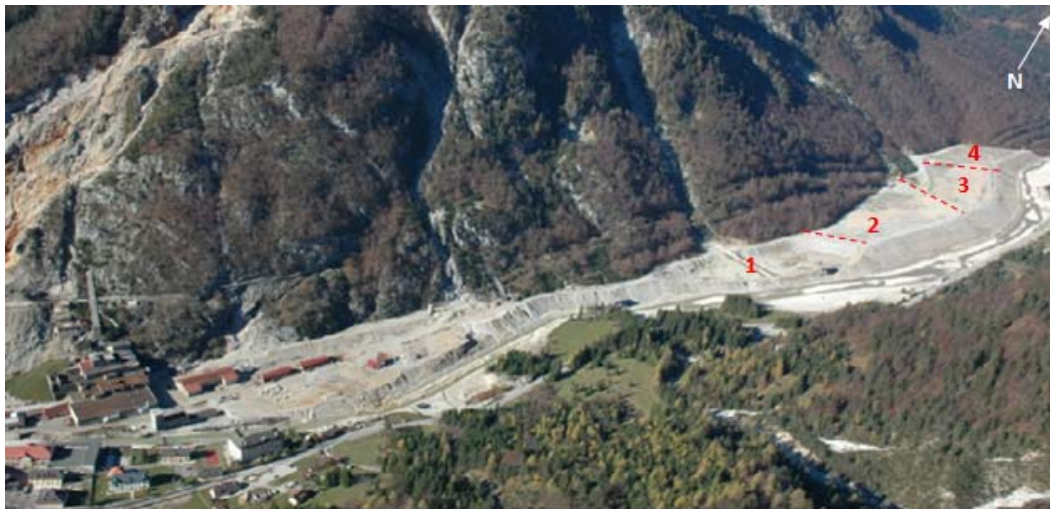
embankments constructed using the coarser soil material resulting from the mine excavations on the other side (Fig. 1). Table 1 displays areas and volumes of the four tailings ponds and Figure 2 is a section across the basin 2, showing the typical structure of a tailings pond.

Figure 1. Aerial view of the old flotation plant area and the tailings ponds.
